**TOWN OF ARLINGTON**  
DEPARTMENT OF PLANNING and  
COMMUNITY DEVELOPMENT

**MEMORANDUM**

RE: Visibility Improvements for Safety at Crosswalk Near Trader Joe's and Starbucks

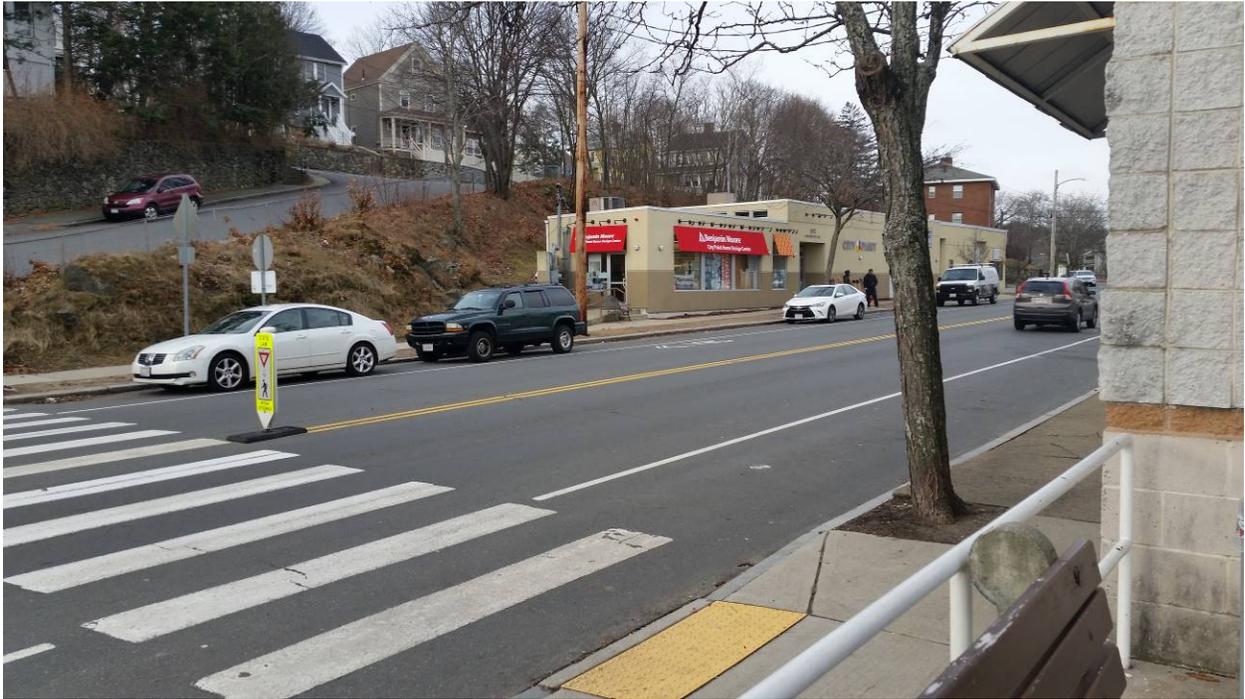
Figure 1: Mass Ave at Dundee Road/Trader Joe's Crosswalk

Besides the standard “ladder” crosswalk pavement markings indicating the crossing, there are also advance pedestrian warning signs for the crosswalk and an in-road pedestrian warning sign. However, there are several issues with this crosswalk that limit visibility of pedestrians entering the crosswalk:

- Drivers are allowed to park on-street immediately adjacent to either side of the crosswalk on the Starbucks side of the road, without any clear space between the vehicle and the crosswalk. On the other side of Mass Ave at Dundee Road, vehicles can similarly park right up to the crosswalk (but not on the other side since that is in the intersection with Dundee Road). This severely limits the visibility of pedestrians entering the crosswalk.

- Eastbound on Mass Ave approaching the crosswalk, there is a sign for the Mystic Valley Freemasons Lodge that is badly worn with peeling paint. This sign is directly in front of the advance pedestrian warning sign for the crosswalk and partially blocks its visibility.

- There is a street light on a utility pole on the Trader Joe's side of Mass Ave approximately 25' east of the crosswalk. This appears to be the closest street light to the crosswalk. There is a utility pole directly adjacent to the crosswalk on the opposite side of the street (near Dundee Road), but there is no street light on this pole. Using a light meter, DPW has confirmed that light levels are low at this location during night time.

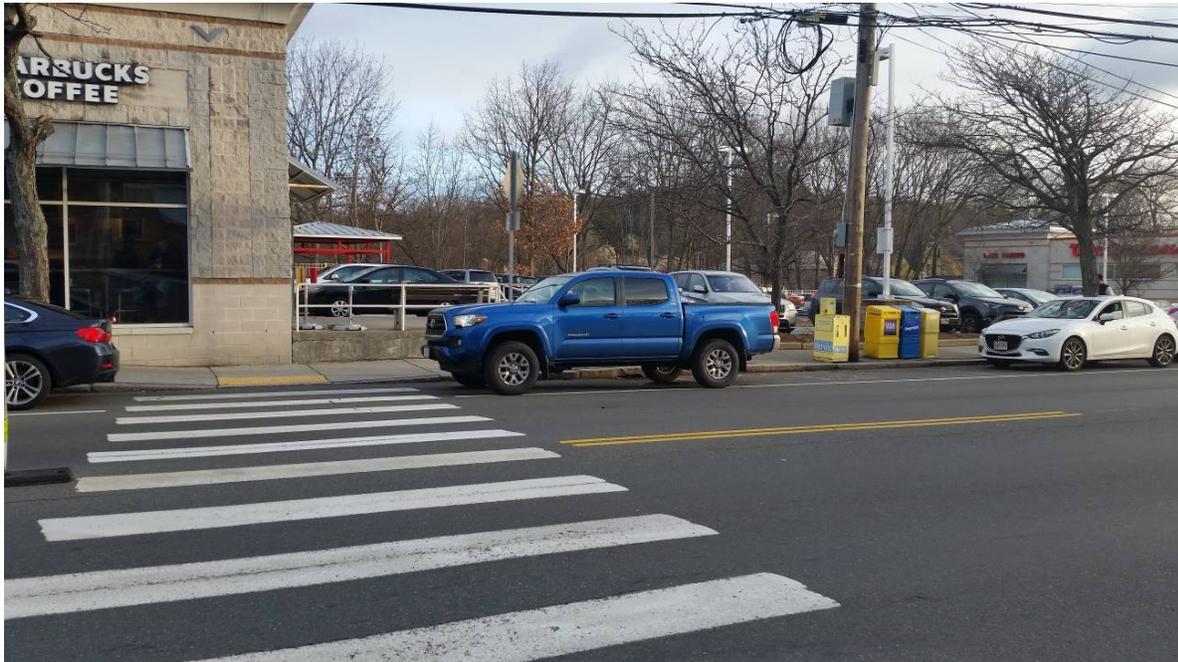
Figure 2: Vehicles parked directly before the crosswalk block visibility of pedestrians entering the crosswalk

- Parking should be restricted with appropriate signage before the crosswalk on the eastbound and westbound approaches to improve visibility. Generally, 20 feet (the length of one parking space) is recommended as a best practice for pedestrian safety for crosswalks. The Transportation Advisory Committee voted to approve new crosswalk guidelines that include the 20 foot parking restriction as a guideline at their January 2019 meeting. However, due to site constraints, the recommendation for each side are as follows:

- On the westbound side, closest to Starbucks, there is a 15' gap between a handicap parking spot and the crosswalk. To avoid moving this parking spot, simply removing parking in between the crosswalk and the handicap spot is sufficient.

- On the eastbound side, parking should be restricted before the crosswalk by 20'.
- Parking should be restricted five feet following the crosswalk on the westbound side to enable motorists to exit the next parking space without backing into the crosswalk.

- Pavement markings should be used to further indicate that parking in these locations is not allowed. Hatch marks (i.e., diagonal lines) can be used for this purpose. A similar treatment can be observed on the westbound side of Mass Ave approaching the crosswalk at Water Street/Peg Spengler Way.
