S5099-001 June 17, 2019

Re: Review of Parking for 118 Westminster Avenue, Arlington, Massachusetts

Parking Evaluation

118 Westminster Avenue, Arlington, MA

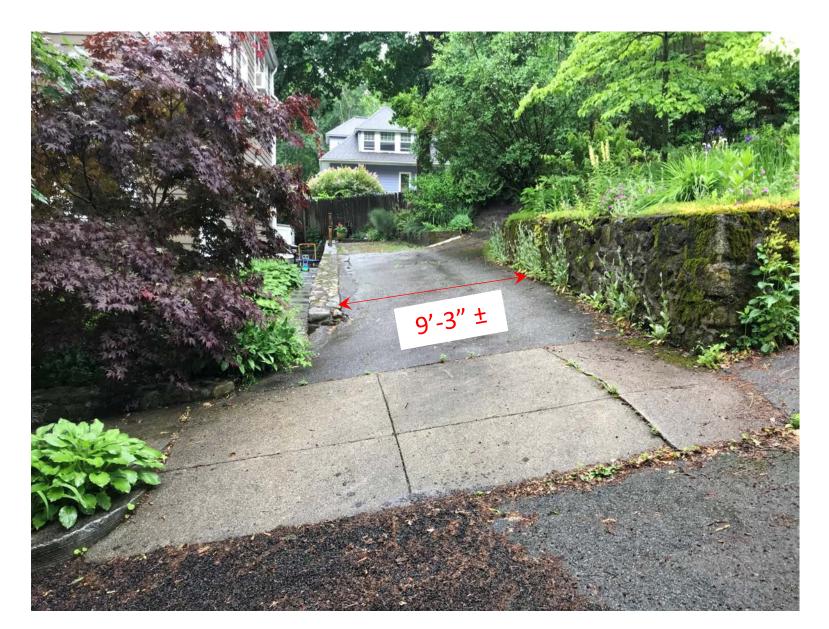
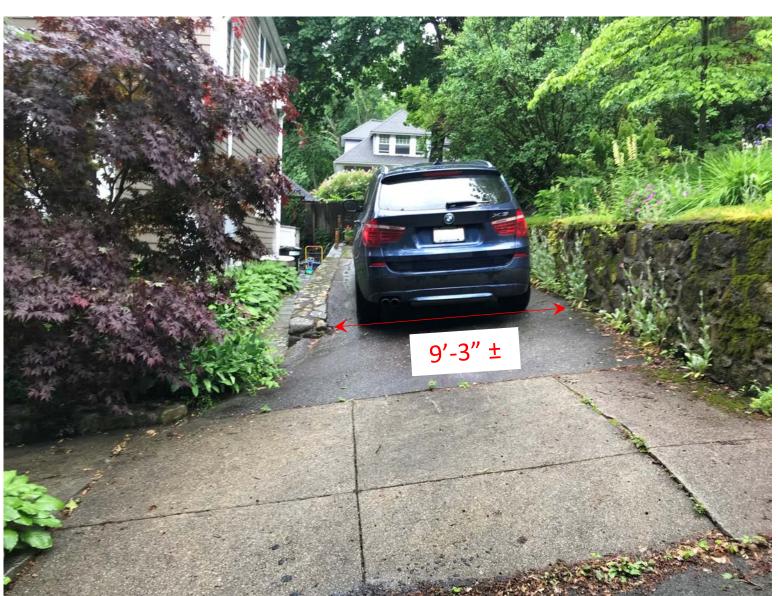
Picture 1 Picture 1A

Pictures 1 and 1A show the approximately 9'-3" wide paved driveway on an easement on the adjacent property, 16 West Court Terrace. In addition to the narrow width, the driveway was constructed along the contours of a steep hillside, resulting in a terraced configuration, with retaining walls on both sides of the driveway. The retaining wall on the left side of the driveway (passenger side) does not have protective railing. The retaining wall on the passenger side does not allow passengers to fully open the doors to exit the vehicle and walk along the driveway on the easement to the Client's driveway and backyard.

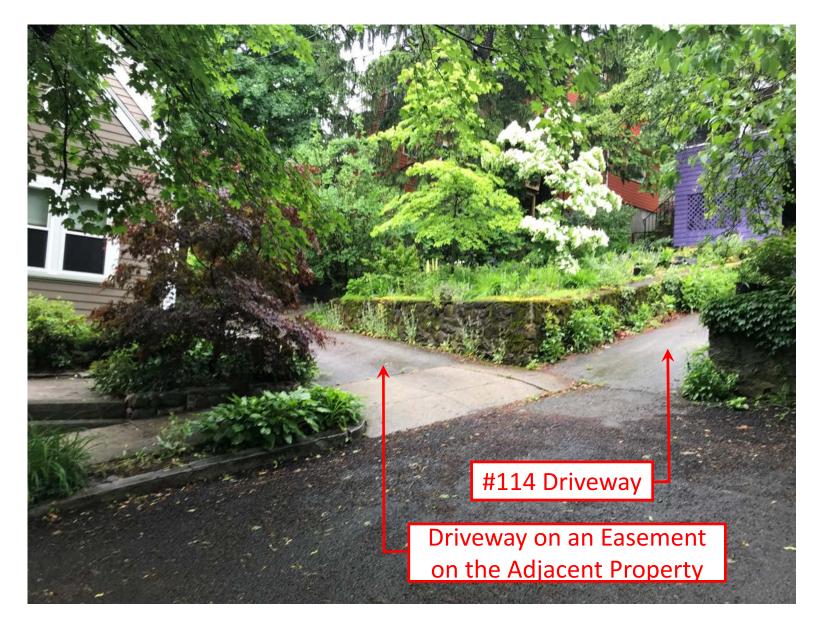
Picture 2 shows the "easement driveway" in proximity to the adjacent perpendicular driveway for #114 Westminster Avenue. Picture 3 shows the view as a vehicle is backing out of the easement driveway, with the view constrained by vegetation, trees and vehicles parked on West Court Terrace.

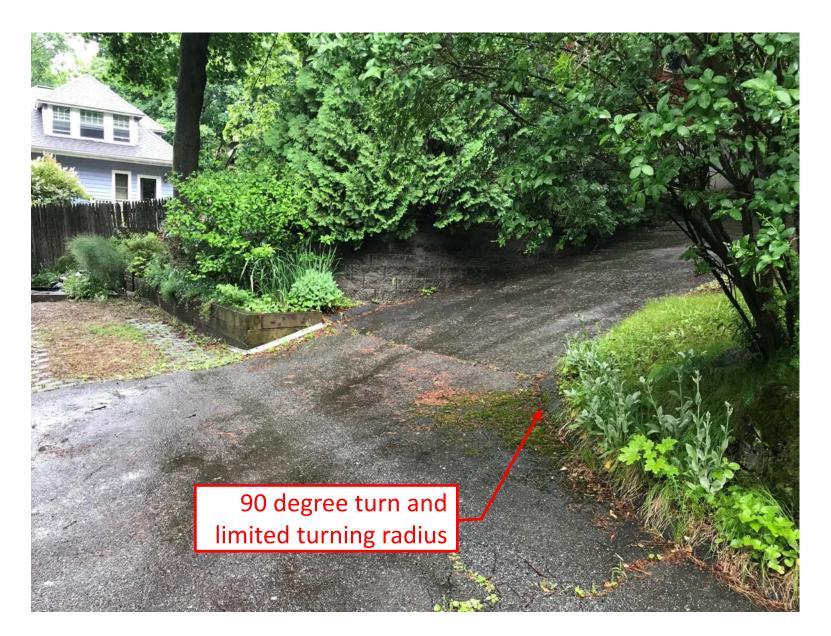
Picture 4 show a 90 degree turn from the narrow easement driveway to the site driveway to access the rear yard of 118 Westminster Avenue. During the site visit in rainy conditions, it was not feasible to complete the turn safely, while preserving the ability to exit by reversing directions on the narrow driveway with sharp turns. Picture 5 shows the rear yard of the site with an approximately 9 foot driveway. Exiting maneuvers can only be accomplished either by traveling in the reverse direction the entire lengths of the site driveway and easement driveway (including two 90 degree turns), or by making a 3-point turn by making use of a granite unit paver driveway extension that may or may not be suitable for vehicle loading.

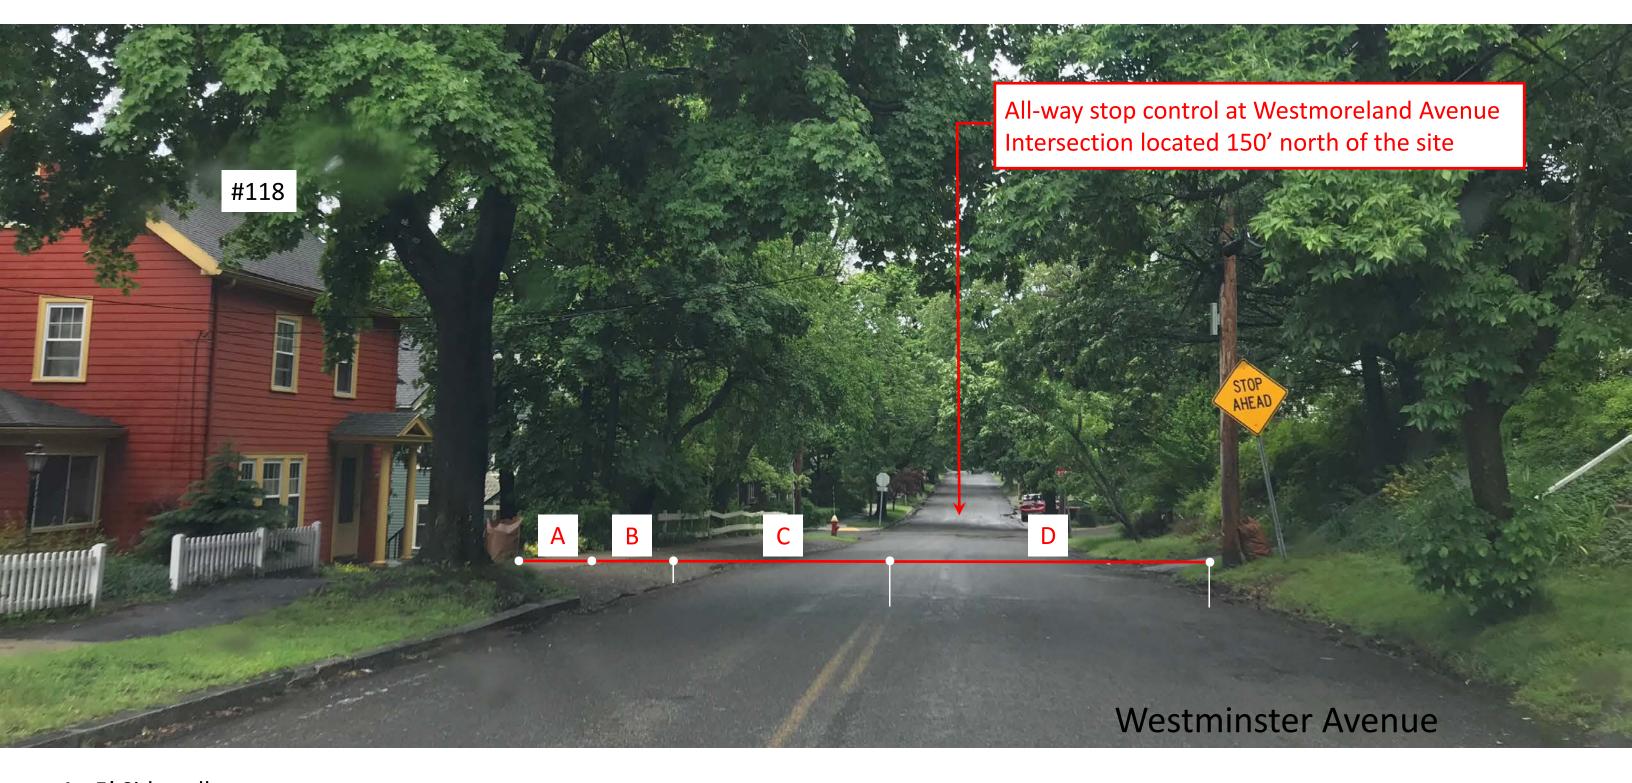
Figure 2: Existing Roadway Cross-Section

A: 5' Sidewalk

B: 6.5' ± Gravel buffer space

C: 13' ± Southbound Travel Lane

D: 15.5' ± Northbound Travel Lane

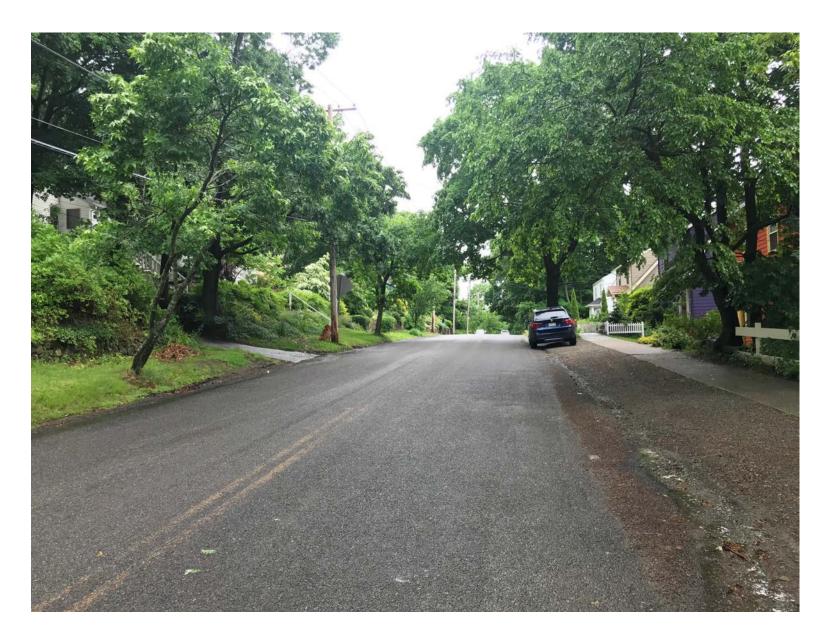
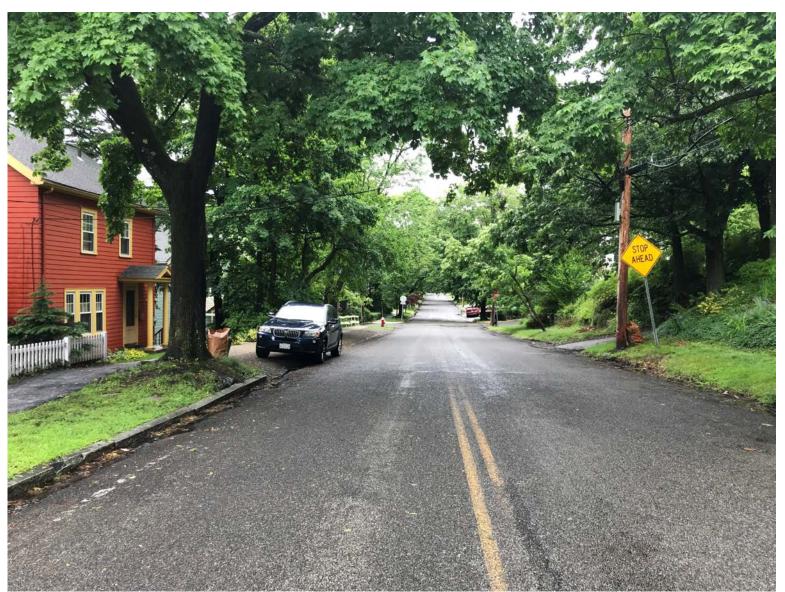
Picture 6 Picture 7

Pictures 6 and 7 shows views on Westminster Avenue looking south and north, respectively, in the vicinity of the site. As shown, use of the gravel buffer separating the sidewalk and the street for on-street parking does not block or otherwise inhibit through vehicle traffic on Westminster Avenue. The pictures also show that the granite curbing along the roadway ends by the large Maple tree located in the buffer space, making on-street parking conducive.

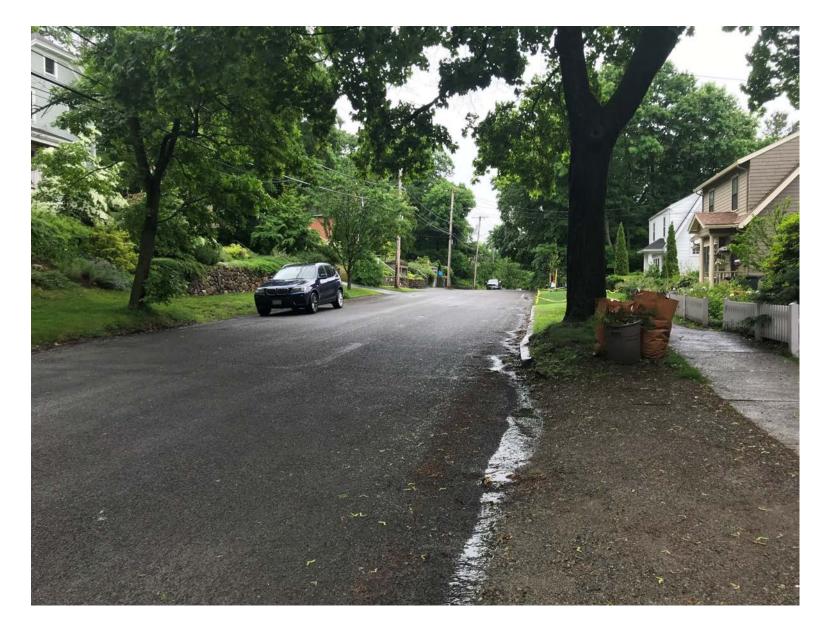
Picture 8 shows a close-up view of the approximately 6.5' gravel buffer space. Picture 9 shows a view to the south, looking from the Westmoreland Avenue approach to Westminster Avenue. As shown, vehicles parked in front of the site do not pose sight line constraints to oncoming traffic.
