## **Docket #3602 - Non-compliance with Massachusetts Architectural Access Board Requirements**

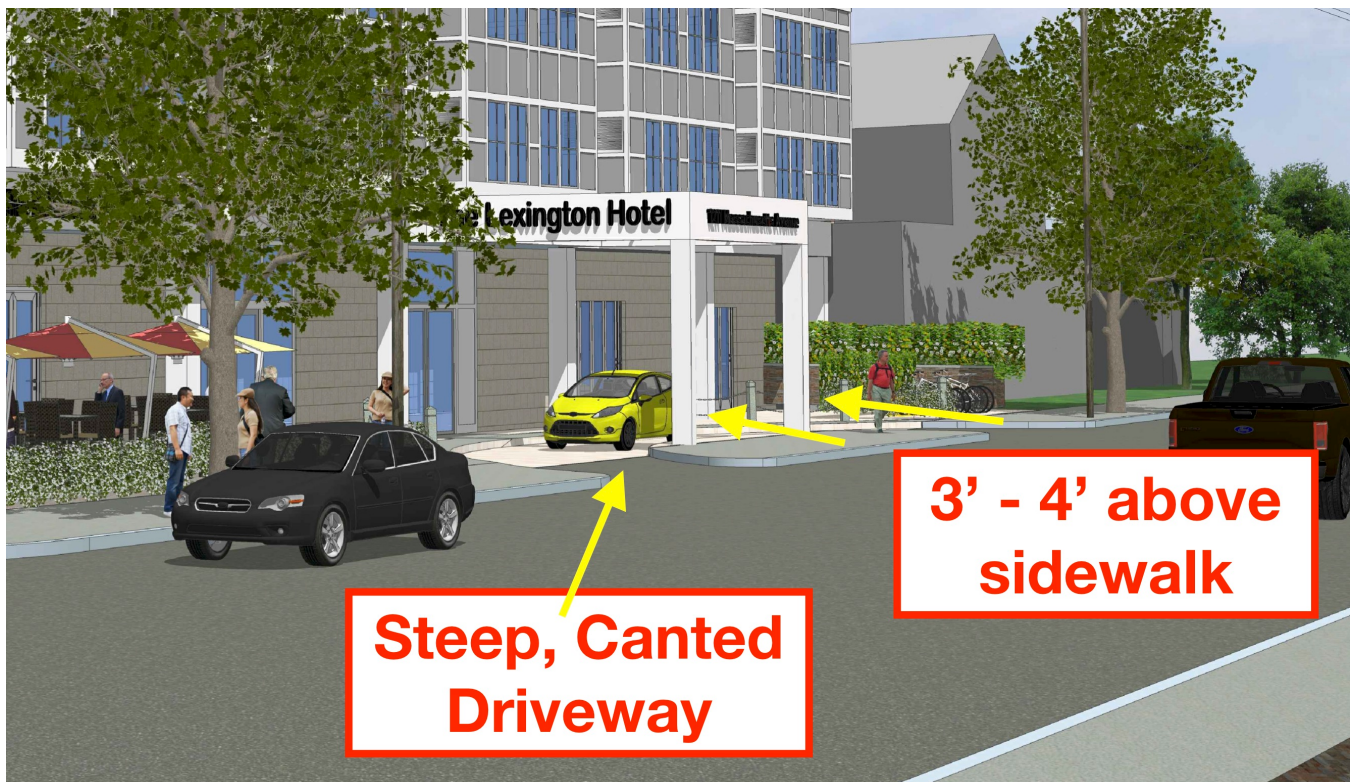
The most recent visualization continues to perpetuate the false notion that this entrance driveway is level. In fact, it is both steep and canted cross-wise. It has to accommodate a three foot drop from hotel entrance to sidewalk in only 24 feet.

Besides being a serious barrier to anyone with disabilities, the conditions of this driveway are unsafe for even able-bodied persons. Anyone exiting from the passenger side will find it exceedingly difficult to open their door; it will swing shut on them as they try to exit. On the driver's side, it will be all too easy to simply fall out of the vehicle. The raised island shown in the visualizations is not raised at all. It is actually a sunken pit, almost two feet below the driveway, with no protective railing to protect the unwary visitor.

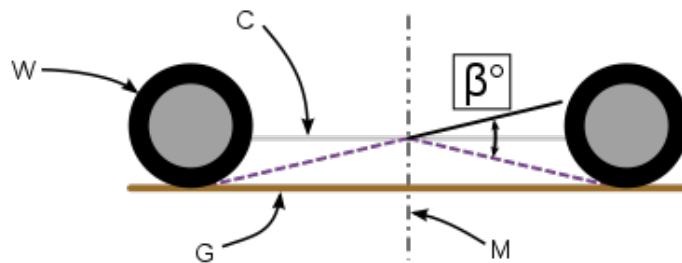
Additionally, there is the "hump" in the middle of the driveway. The two opposite slopes create a "Breakover Angle" of  $13.2^\circ$ . Many common passenger vehicles do not have sufficient ground clearance to bridge this hump. An unloaded Toyota Camry will bottom out at  $11.7^\circ$ . A Prius at  $11^\circ$ , Hyundai Sonata and Ford Fusion at  $10.8^\circ$ , Chevy Malibu  $9.4^\circ$ . A Mercedes E class sedan can tolerate only  $7.4^\circ$  and will likely incur serious damage trying to bridge the hump.  
[https://en.wikipedia.org/wiki/Breakover\\_angle](https://en.wikipedia.org/wiki/Breakover_angle)
