Dear Arlington Selectboard,

The intersection of Park Avenue and Route 2's frontage roads has always been one of the most congested in the town. However, in the past few years, maintenance levels have dropped, and dangerous behavior has increased. This is a list of recommendations to be made in accordance with Connect Arlington and best practices.

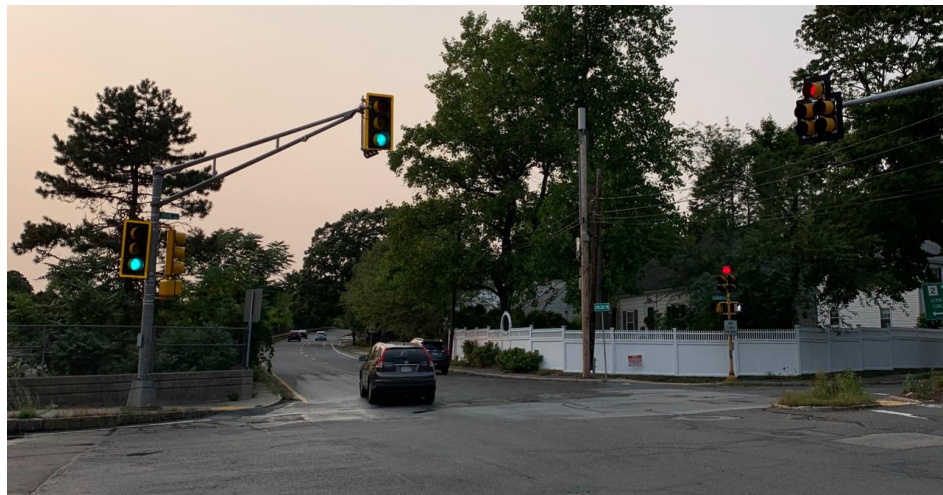
Maintenance at these signals is also infrequent. Concord Turnpike's approach on Arlington's side of the interchange has an extremely dangerous situation that could confuse a driver into thinking

they had a green light, because of a missing visor on a Park Avenue signal, as seen in the photo to the right. Furthermore, outdated "doghouse" style left turn signals currently exist at this

- Perform maintenance on this signal, to check that it is up to MassDOT standards.
- Install Flashing Yellow Arrow left turn signals to replace older style 5-section signals.
 - Program a pedestrian protect phase, so that if a pedestrian clicks the crosswalk button, left turns are converted to protected only so that pedestrians can cross in a safer manner. (See image on right)
