From: Don Seltzer <timoneer@gmail.com>
 To: Rachel Zsembery <rzsembery@town.arlington.ma.us>, KLa@town.arlington.ma.us, Eugene Benson <EBenson@town.arlington.ma.us>, MTintocalis@town.arlington.ma.us, Stephen Revilak <srevilak@town.arlington.ma.us>
 Cc: Claire Ricker <cricker@town.arlington.ma.us>, Kelly Lynema <klynema@town.arlington.ma.us>
 Date: Sat, 21 Jan 2023 11:03:52 -0500
 Subject: Docket 3560 - 190 Mass Ave Ceiling Height issues

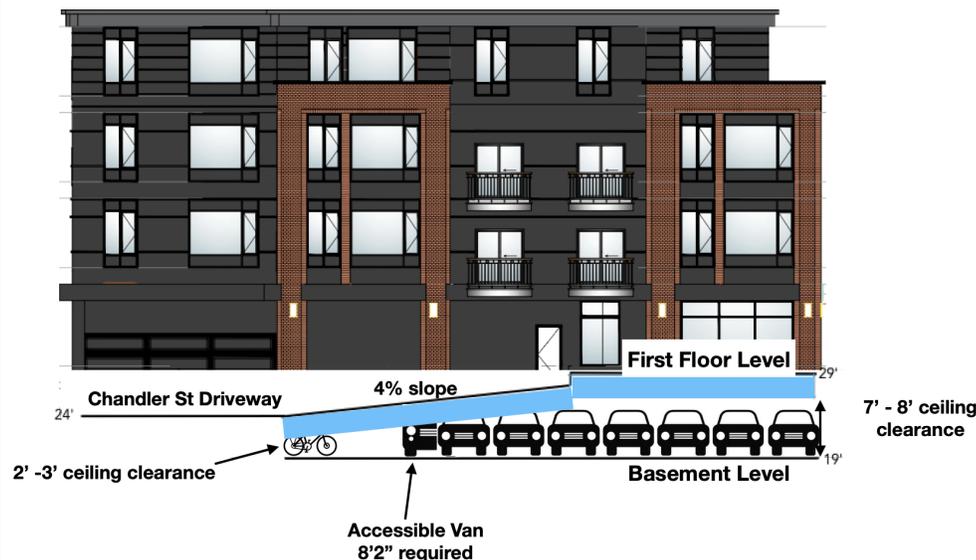
The first floor retail space is at an elevation of 29', slightly above that of Mass Ave. The terrain is sloped downward along Chandler St with the entrance to the parking garage at an elevation of 24'.

The eight tandem parking spaces at street level are sloped at about 4%. There is an entrance ramp leading to the lower level. It descends at a very steep slope of 13% over a run of about 38', dropping down to the lower level elevation of 19'.

A portion of the below grade parking is at 10' below the first floor elevation. Accounting for ceiling structure, the actual clearance is probably 7' - 8'.

Another portion of the below grade parking is under the sloped tandem parking area, with the height clearance dwindling down to only 2' - 3'. This includes the bicycle storage area, the HP van space, and three of the EV car spaces.

Clearly this is impractical. It is also unacceptable under state law which requires that there be a minimum access route clearance of 8'2" for HP vans.

The change in grade from the 24' elevation Chandler St entrance to the 19' parking level is provided by a short, dangerously steep ramp, 13% grade over approximately 38'. Design standards for such ramps recommend that steep ramps over 10% have transition zones with slopes of half the grade. In this instance, the Chandler St entrance driveway should transition to a ramp of 6.5% with a length of least 8', then the 13% ramp, followed by a second 6.5% transition ramp before reaching the level parking area.

A related problem with the underground parking is the apparent lack of two independent routes of egress from the lower level of the garage. 780 CMR requires that escape exits be located as remote from each other as practicable. In these plans, the two stairwells are almost adjacent and lead to a single corridor and exit to the outside on the first level. Perhaps the applicant is counting the vehicle ramp as a second method of egress. However, ramps used for egress may not have a slope greater than 8%, and must further have a landing area for every 30" of rise. The proposed design does not satisfy either requirement.

Significant redesign is necessary, and may not even be possible considering the limitations of this property. A 11,000 sf lot is not very big and probably cannot accommodate underground parking with safe ramp access. A similar problem arose with an application for a 16,000 sf lot at 10 Sunnyside that came before this Board several years ago. The underground parking was to be accessed by a dangerous 15% ramp with no transition zones at either the street level sidewalk nor the lower level parking.
