Wildlife Habitat and Vegetation Evaluation

Thorndike Place

Arlington, MA

November 2020

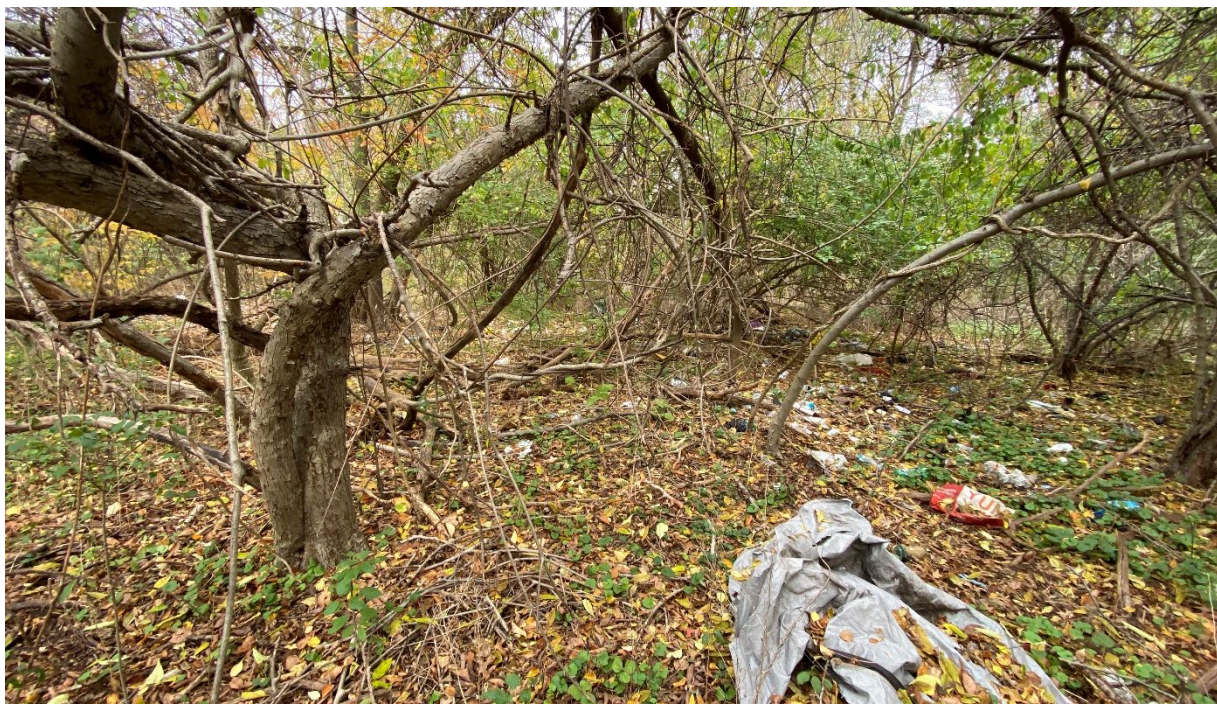
Evidence of human disturbance including refuse
Extensive exotic invasive plants
- AU-C16 Terrestrial deciduous forest
Tree canopy 65% cover with Tree of Heaven (30%), American Elm (10%), and Cherry (5%)
Tree sub-canopy layer composed of very old fruit trees (25%)
Tangled shrub layer of Amur Honeysuckle (5%), vines (20%) including Bittersweet
Herbaceous layer 75% cover composed of Garlic Mustard

Topography is gently sloping toward C-series wetland
There is a small amount of downed woody debris (15%) with moderate fuel loads
No snags >4" DBH; no cavities observed
No small mammal burrows observed

Significant amount of trash and waste materials in this location
Extensive exotic invasive plants
- AU-D18 Terrestrial deciduous forest with relatively open understory
Tree canopy 75% composed of Black Cherry (70%) and Silver Maple (5%)
Tree sub-canopy and shrub layer 30% with Black Cherry, Poison Sumac, and Tree-of-Heaven
Shrub and herbaceous layer 60% composed of American Pokeweed, Goldenrod, Buckthorn

AU-C16 #878: Old apple/fruit trees and refuse associated with encampment.

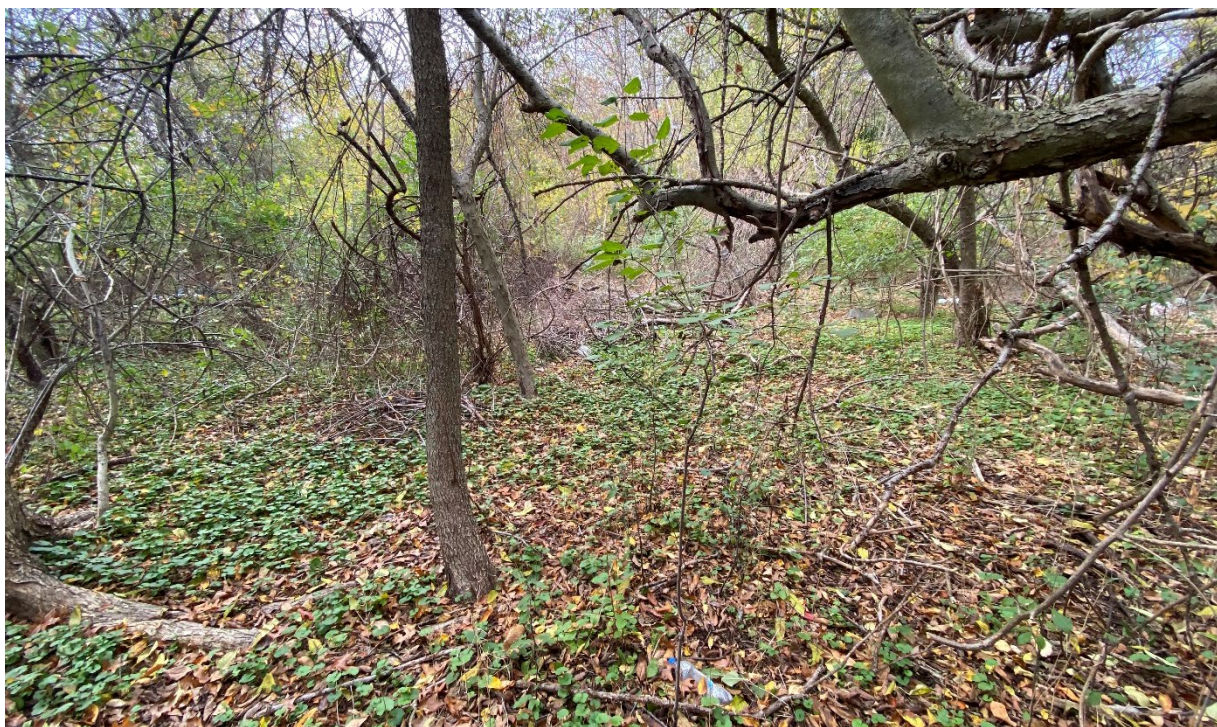
AU-C16 #880: Garlic mustard understory

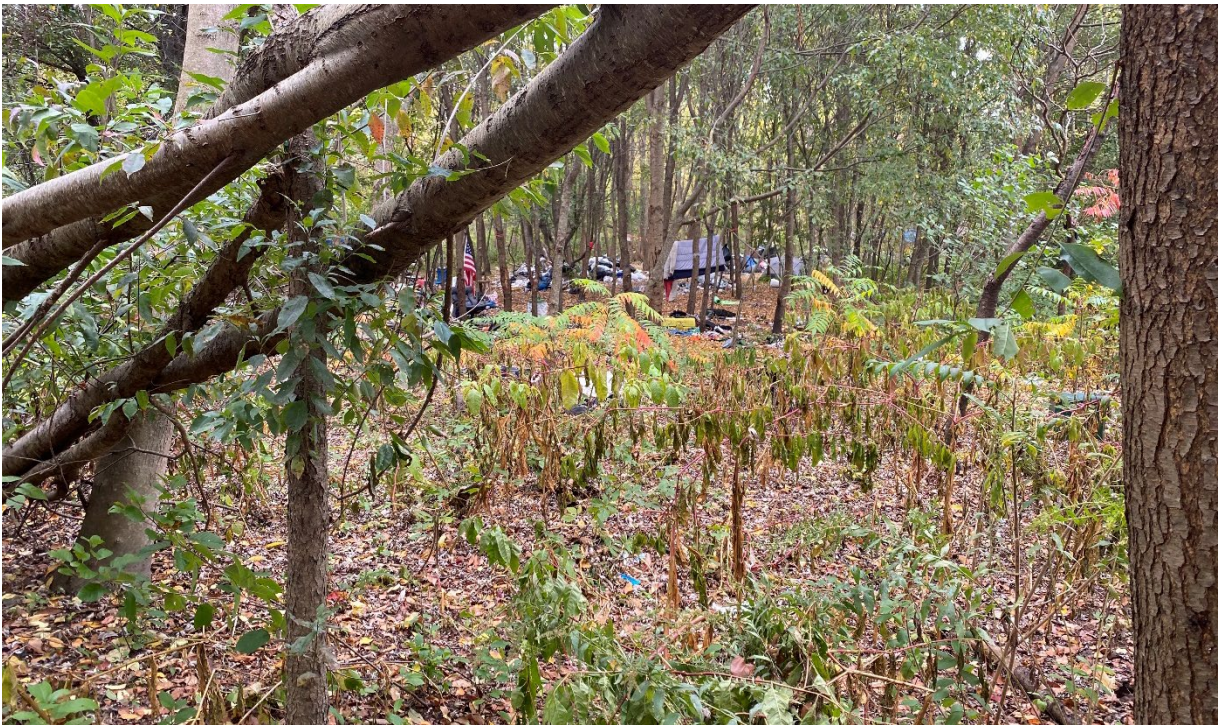
Immediately adjacent to the largest encampment on the property.
Survey Plot has the least Garlic Mustard on the site
Evidence of dumping including concrete and macadam
Impact of highway evident

It is important to note the adverse effects on wildlife habitat values in the forest and wetlands on the project site resulting from the extensive human encampment. The extensive amount of trash that is spread throughout the site has a direct effect of eliminating important wildlife habitat functions. Trash may be construed to provide shelter for some species, and may attract prey organisms, but it eliminates natural

cover, may introduce toxins to soil and water resources, and expands the footprint of human habitation which most wildlife make an effort to avoid.

The encampment on the site of the proposed project has a direct negative impact on the wildlife habitat values of the woods and wetlands.

AU-D18 #882: Homeless encampment has a significant effect on wildlife habitat values of forest and wetlands on the site.

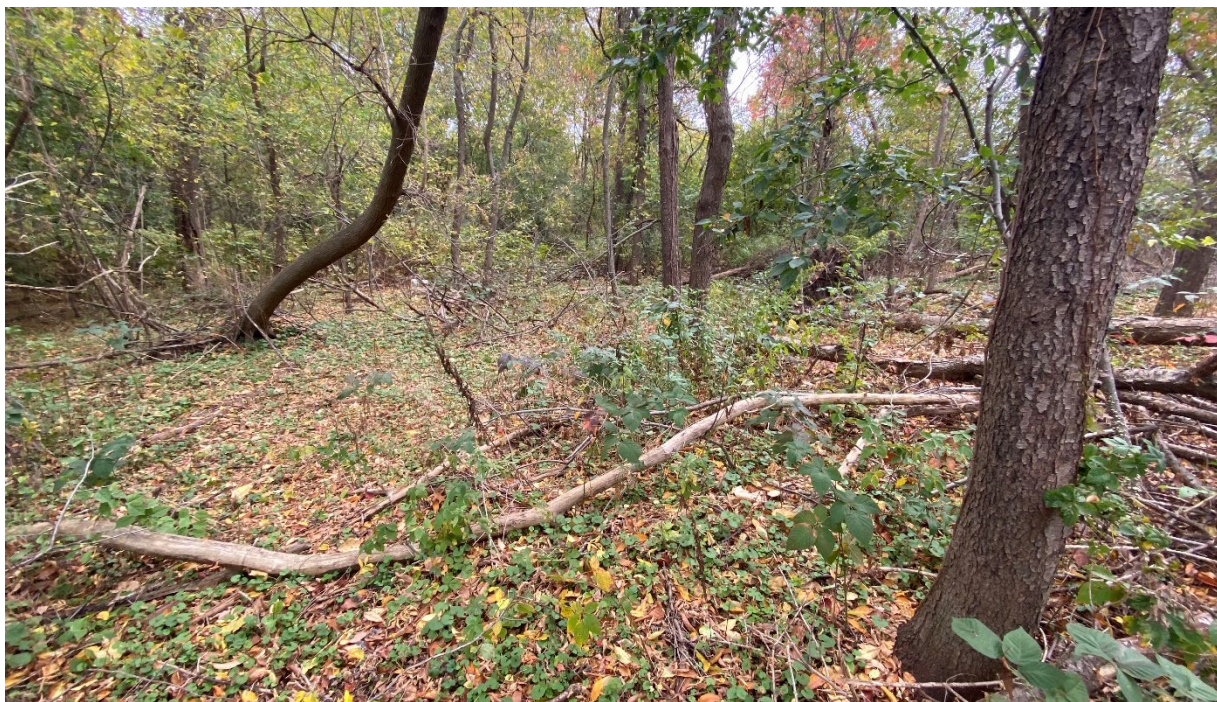
- FP-1 Terrestrial deciduous forest with moderate understory
 Tree canopy 80% composed of Cherry (60%), Box Elder (20%) and Black Oak (5%)
 Understory composed of brambles, Chokecherry (10%), American Pokeweed (10%)
 Herbaceous layer 80% composed of Garlic Mustard (70%), Goldenrod (5%)

- Topography is generally flat
 There is a moderate amount of downed woody debris (25%) and moderate fuel load
 One snag 4" DBH present
- Invasive exotic shrubs/vines are present but sparse, including Bittersweet, Knotweed
 There are abundant plants that produce food for wildlife
 Some evidence of the homeless encampment, including trash within survey plot
 Evidence of dumping including concrete and macadam

FP-1 #876: Relatively open understory with coarse woody debris and mature overstory trees.

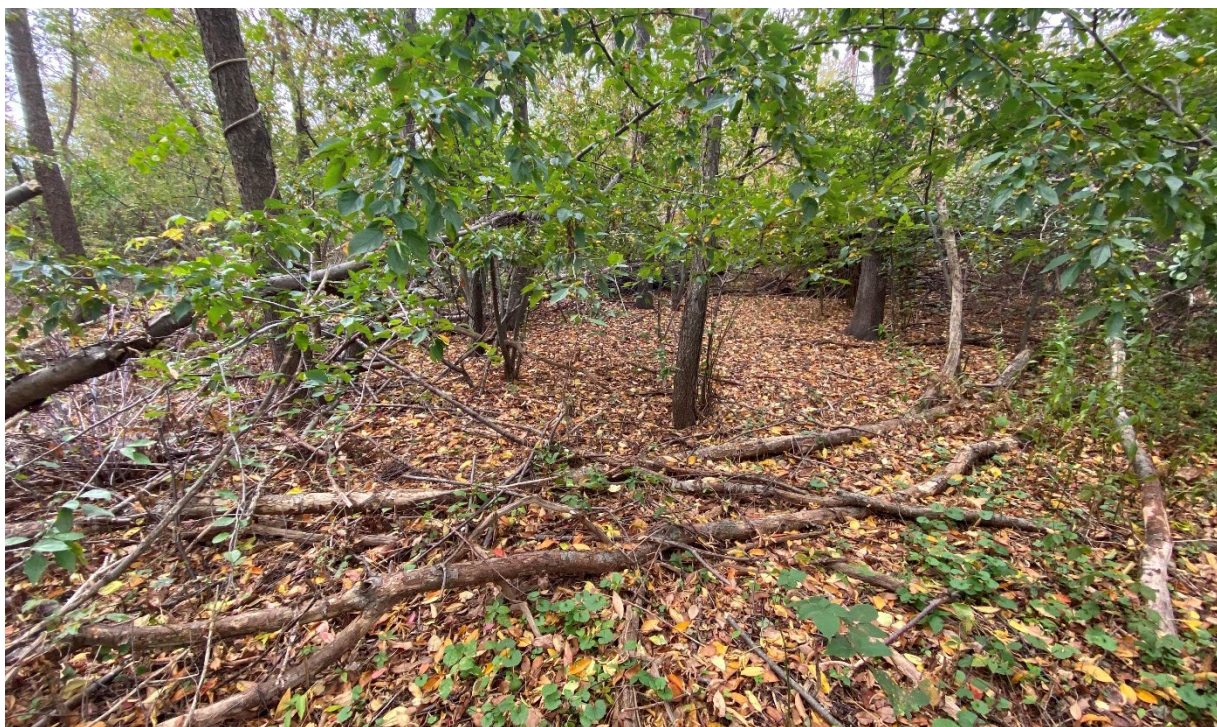
FP-1 #877: Oak and chokecherry occur over garlic mustard

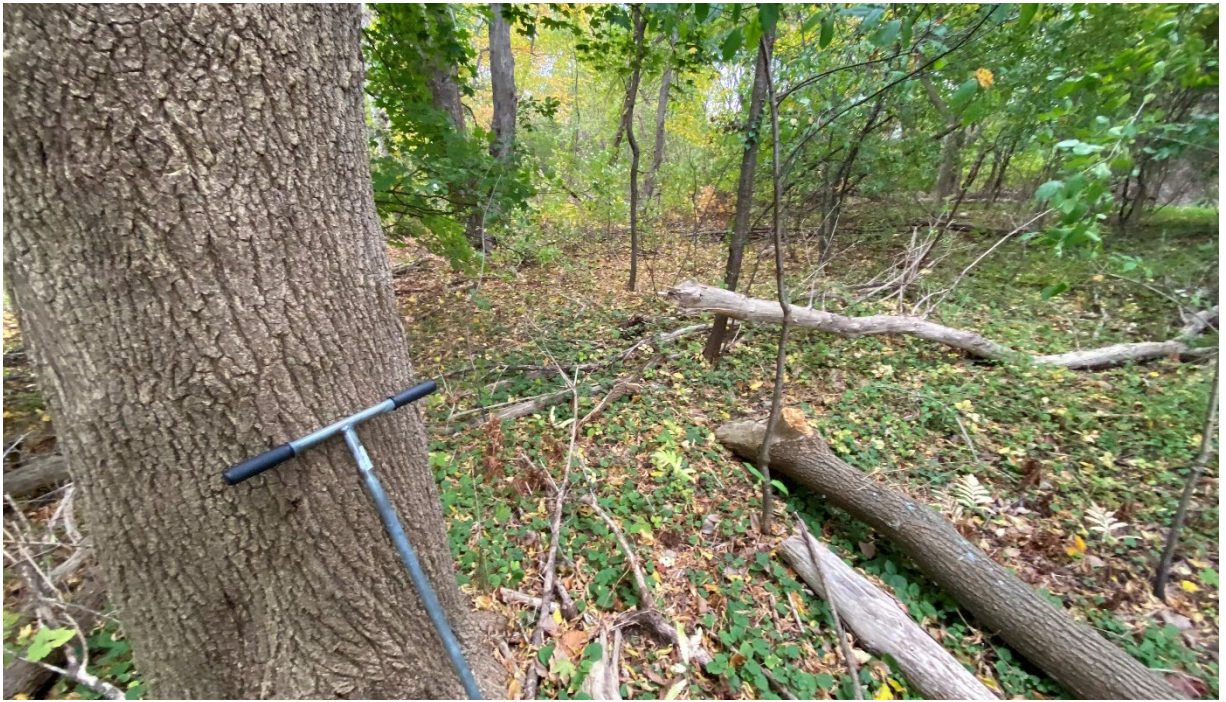
- FP-2 Terrestrial deciduous forest with fairly open understory
 Tree canopy 80% with Ash (20%), Norway Maple (40%), Red Maple (10%), Elm (5%)
 Tree sub-canopy and shrub layer composed of Cherry (5%), Norway Maple (5%)
 Herbaceous layer 90% composed of Garlic Mustard, Sensitive Fern, ivy

- Topography is generally flat
 Small amount of downed woody debris, including 18" DBH trunk, moderate fuel load
- Survey plot includes some very large trees, including specimens of 24" and 30" DBH
 Site is close to Dorothy Road and there is evidence of yard waste dumping
 Evidence of dumping concrete macadam

FP-2 #874: Large mature trees in overstory, with a sparse understory and a lot of coarse woody debris.

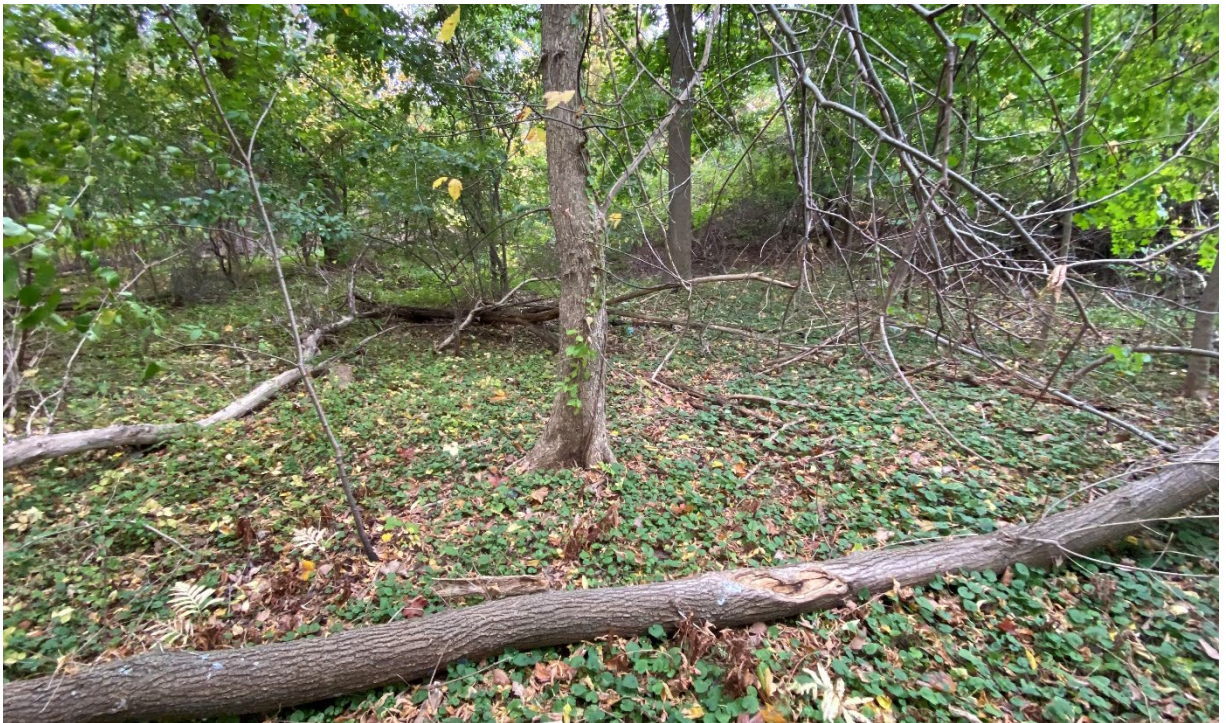
FP-1 #875: Area has sensitive fern and poison ivy and other indicators of moist floodplain conditions.

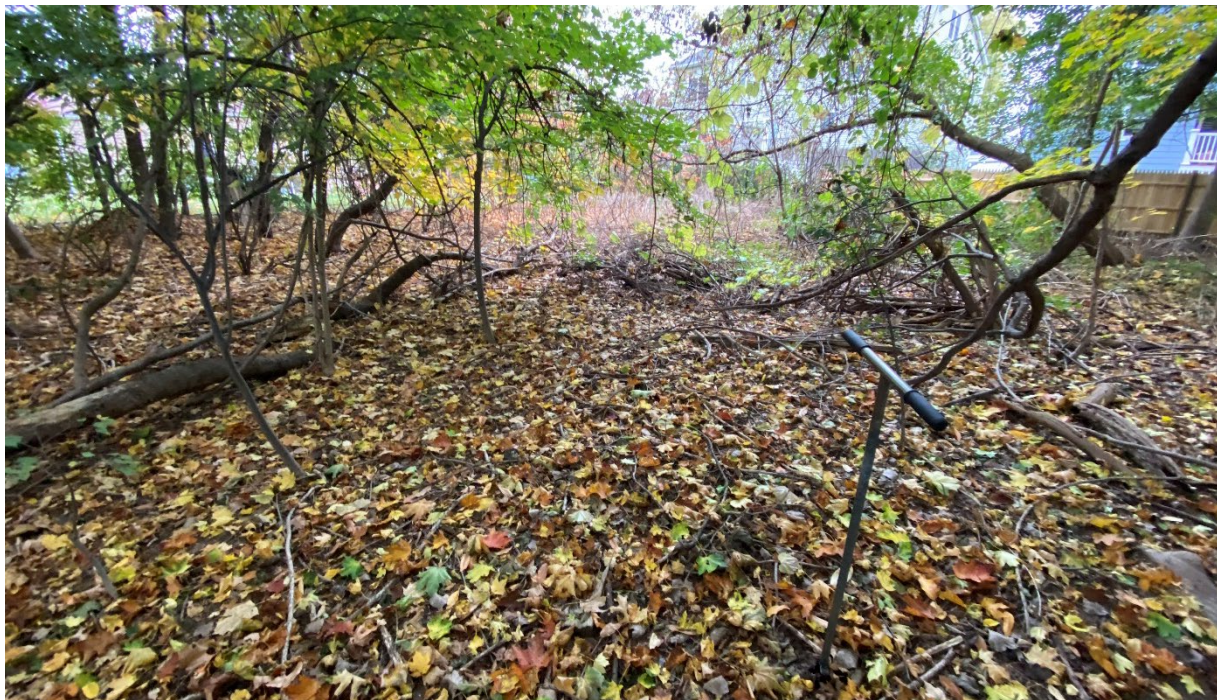
- CS-1 Terrestrial deciduous forest with open understory
 Tree canopy 100% composed of Norway Maple. Elm and Cherry present (Tr)
 Understory has trace amount of Linden and Bittersweet
- Topography gently sloping to the west
 Small amount of downed wood debris (5%) with moderate fuel load
 No snags observed; no cavities observed
 No small mammal burrows observed
- Some residential encroachment of lawn area, but no other evidence of impacts
 Garlic mustard is present outside of plot at fence line
- CS-2 Located within encampment and therefore not surveyed

CS-1 #869: Very open understory under complete canopy of a large Norway Maple.

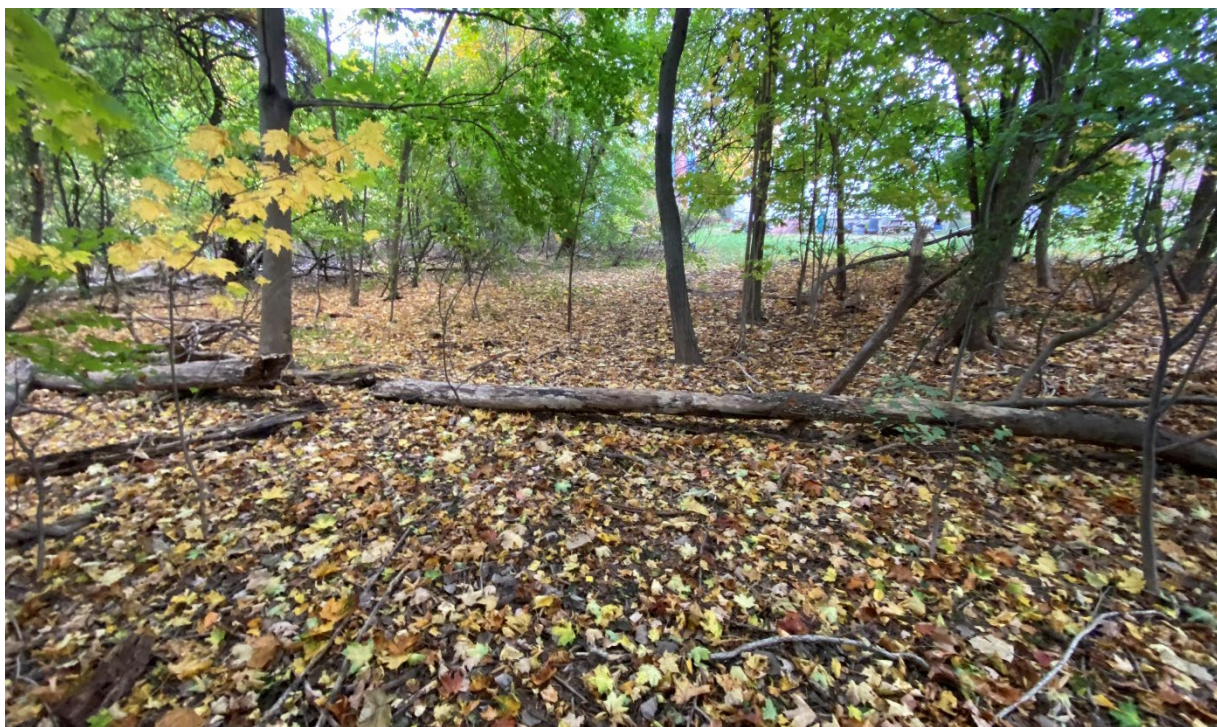
CS-1 #870: Survey Plot was very sparse in the understory and ground cover, with some coarse woody debris.
