**Alewife and Mill Brook: Mystic Headwaters Project 2013-01/604**

**Egerton Road, Arlington  
Concept Plan for a Green Infrastructure Retrofit**

**Town of Arlington, MA**

October 2014

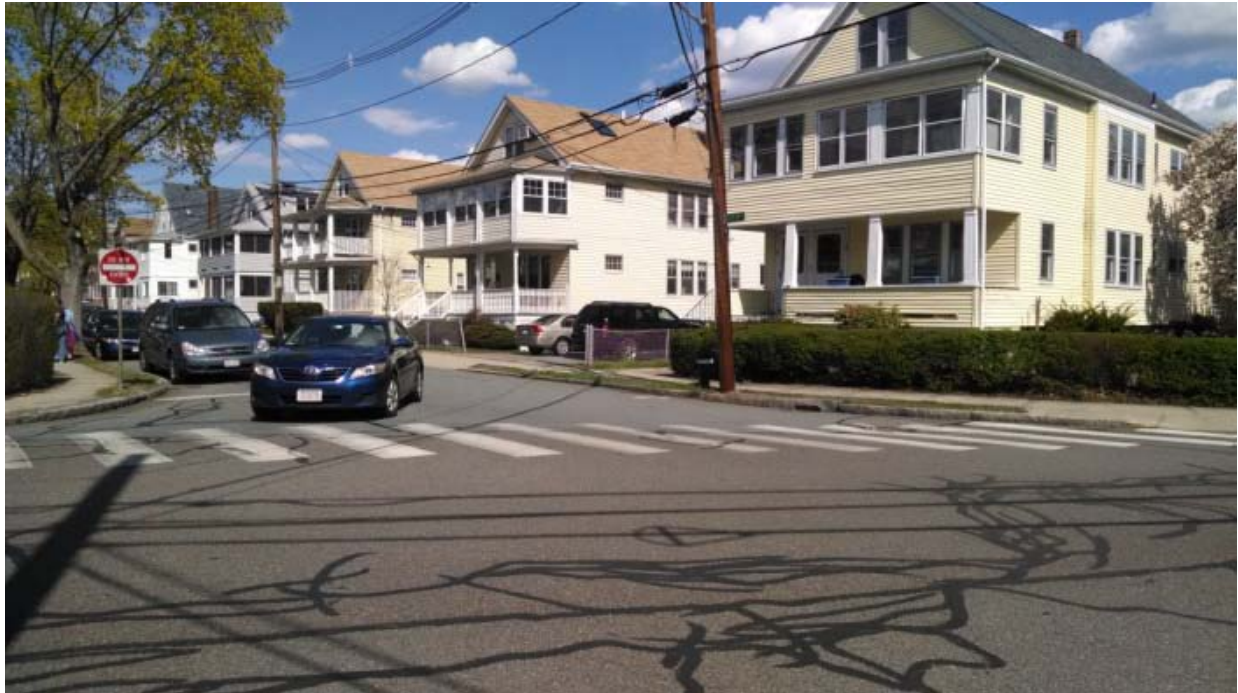
**Photo 1. Egerton Road looking northeast from Herbert Road**

Egerton Road is a one-way street, approximately 26 feet wide, surrounded by multi-family houses on small lots. Two catch basins, on the northeast and southeast corners of Egerton at Herbert, capture runoff from the road surface, roofs and driveways extending approximately 260 feet toward Massachusetts Ave. This runoff currently flows to Alewife Brook without treatment.

On-street parking is allowed on both sides of Egerton Road. A water line runs along the south side of Egerton; a sewer line down the center; and a gas line along the north side. Gas and water line conflicts will need to be considered in the final design. A fire hydrant is located next to the catch basin at the southeast corner of Egerton and Herbert.

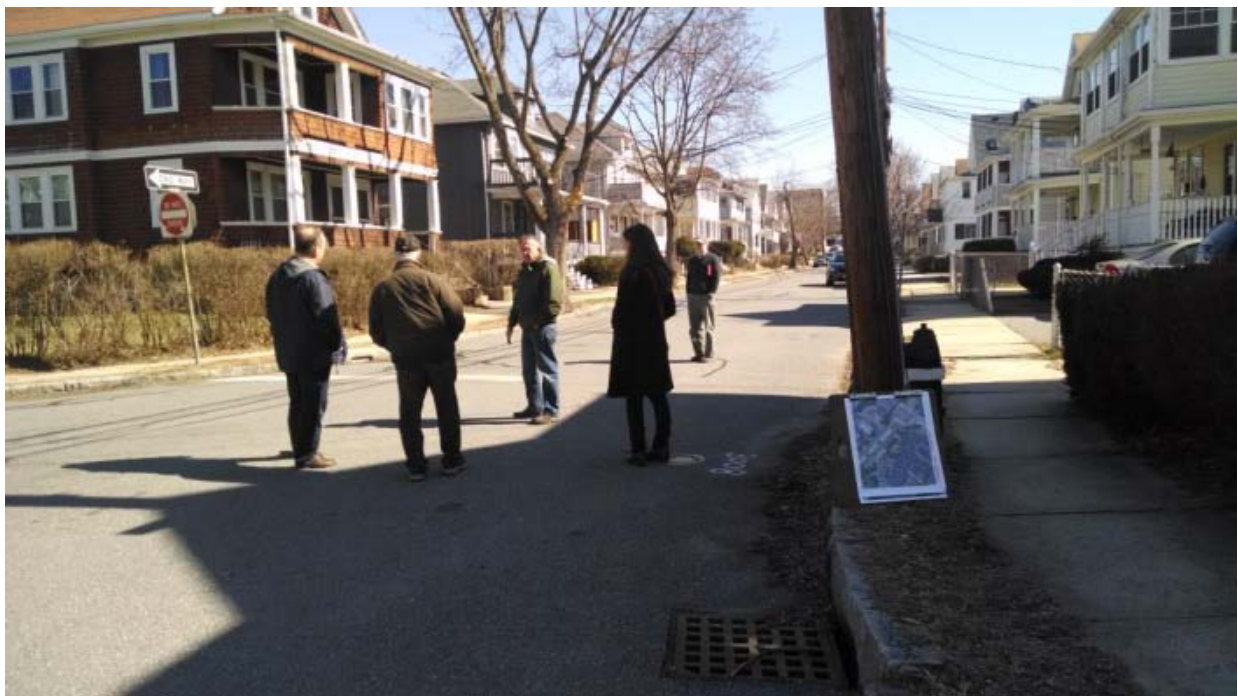
**Photo 2. Storm drain and hydrant on south side of intersection**
