S5099-001 June 17, 2019

Re: Review of Parking for 118 Westminster Avenue, Arlington, Massachusetts

Parking Evaluation

118 Westminster Avenue, Arlington, MA

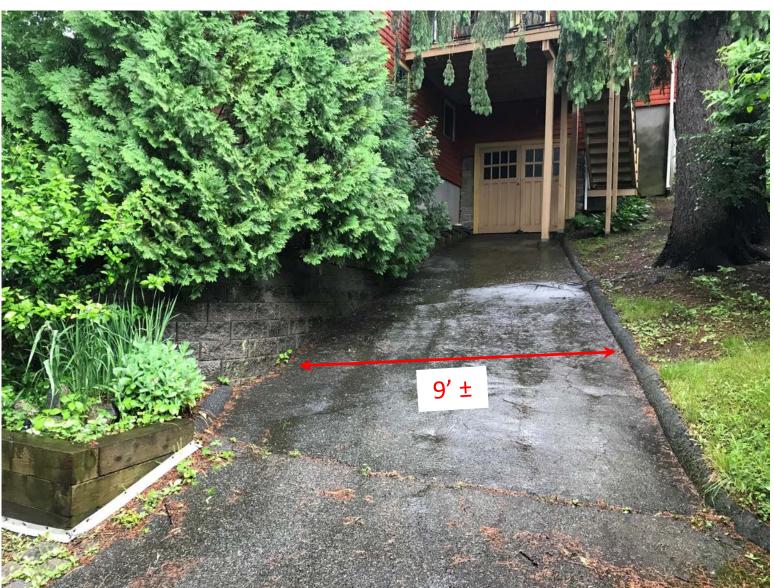
Picture 4 Picture 5

Picture 4 show a 90 degree turn from the narrow easement driveway to the site driveway to access the rear yard of 118 Westminster Avenue. During the site visit in rainy conditions, it was not feasible to complete the turn safely, while preserving the ability to exit by reversing directions on the narrow driveway with sharp turns. Picture 5 shows the rear yard of the site with an approximately 9 foot driveway. Exiting maneuvers can only be accomplished either by traveling in the reverse direction the entire lengths of the site driveway and easement driveway (including two 90 degree turns), or by making a 3-point turn by making use of a granite unit paver driveway extension that may or may not be suitable for vehicle loading.
