RE: 46 Spy Pond Parkway, Arlington, MA
DEP Number: 091-0300

PERMEABLE PAVER MAINTENANCE GUIDE

12 FOOT VEGETATION BUFFER
46 SPY POND PARKWAY
ARLINGTON, MA
MAY 2020

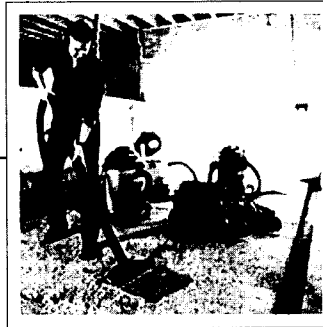
1. Wet/Dry Shop Vacuum

- Minimum 4 HP (peak) motor with 130 cubic feet per minute suction.
- Will remove some joint aggregate material.
- Replenish removed joint aggregate material to "lip" of paver.
- Approximate cost: \$50 to \$150.

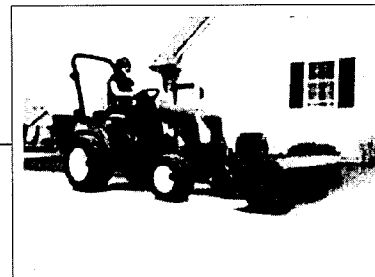
1. Rotary Brush

- Poly bristles only.
- Flips debris from joint.
- Will require slight refilling of the joint aggregate material.
- Approximate cost: Varies depending on attachment vehicle.

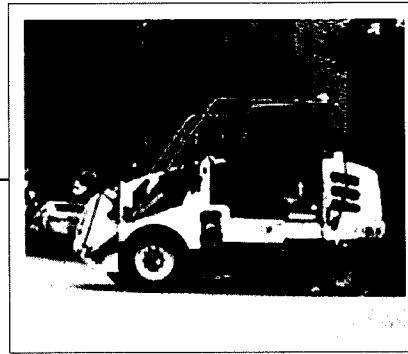
2. Broom Sweepers

- Typical “street sweeper” type.
- Rotating curb brushes with center pickup.
- Poly bristles only.
- Do not utilize water to clean the surface as this can have detrimental effects on the cleaning.
- Best for seasonal cleaning.
- Approximate cost: \$100 to \$120 per hour from a service company.

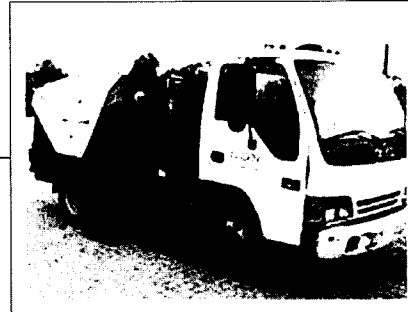
3. Regenerative Air Sweepers

- Light duty suction cleaning.
- Utilizes stream of air blowing horizontally across surface and vacuuming.
- No rotating brushes.
- Approximate cost: \$45 to \$65 per hour from a service company.

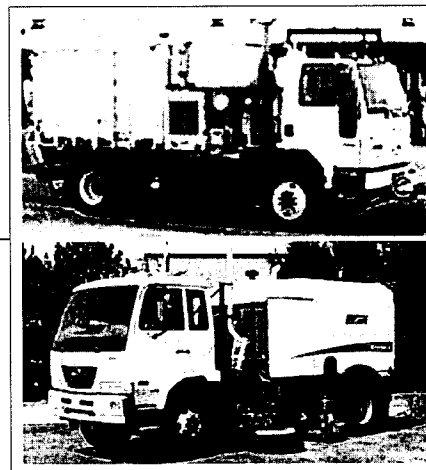
1. Vacuum Sweepers

- Vacall Dynamic Multi-Purpose Vacuum.
(top photo)
- Elgin Whirlwind.
(bottom photo)
- Heavy duty cleaning.
- Minimum suction of 14,000 cubic feet per minute.
- Complete evacuation of joint aggregate material.
- Replenish removed joint aggregate material to “lip” of paver.
- Approximate cost: \$2.50 to \$4.50 per parking space.
